NASA CR-112119-2

**EVALUATION OF COATED COLUMBIUM ALLOY
HEAT SHIELDS FOR SPACE SHUTTLE
THERMAL PROTECTION SYSTEM APPLICATION**

PHASE II ♦ SUBSIZE HEAT SHIELD AND SMALL SIZE TPS EVALUATION

Prepared by
CONVAIR AEROSPACE DIVISION OF GENERAL DYNAMICS
San Diego, California

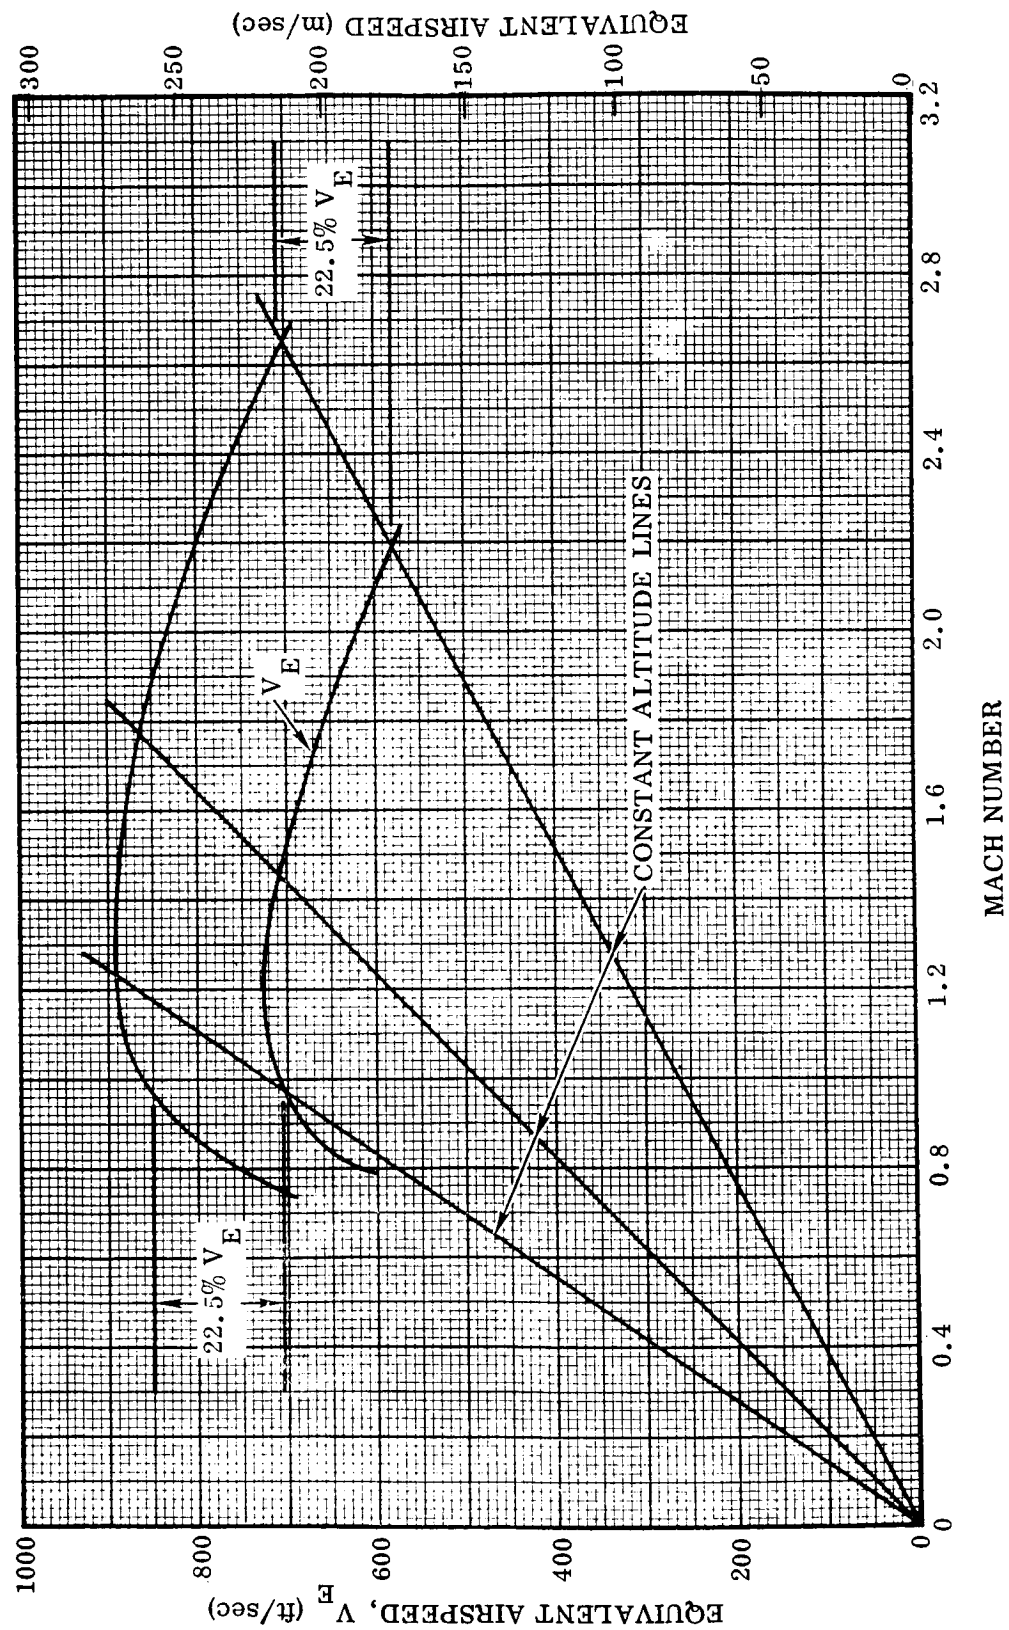
Figure 6-61. Equivalent Airspeed Versus Mach Number During Boost Phase

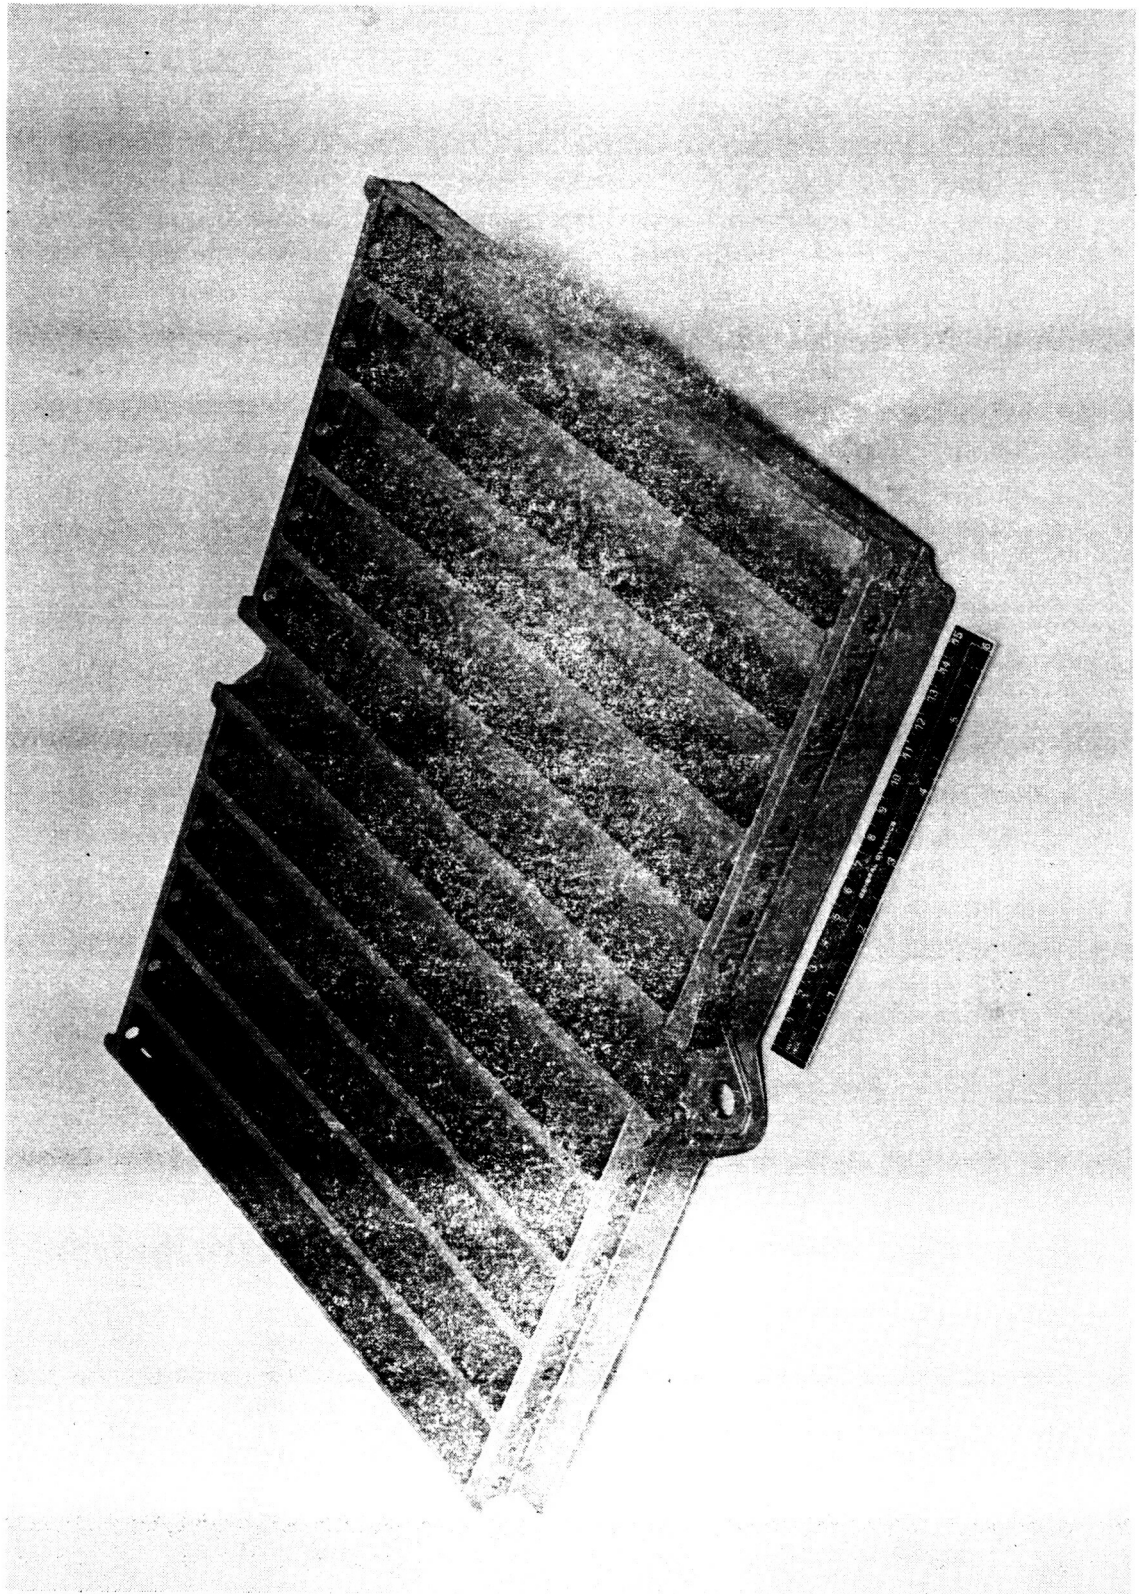
Figure 7-6. Tee-Stiffened Cb-752 Heat Shield Panel -- Interior Side Ready for Coating (Photo No. 128326B)

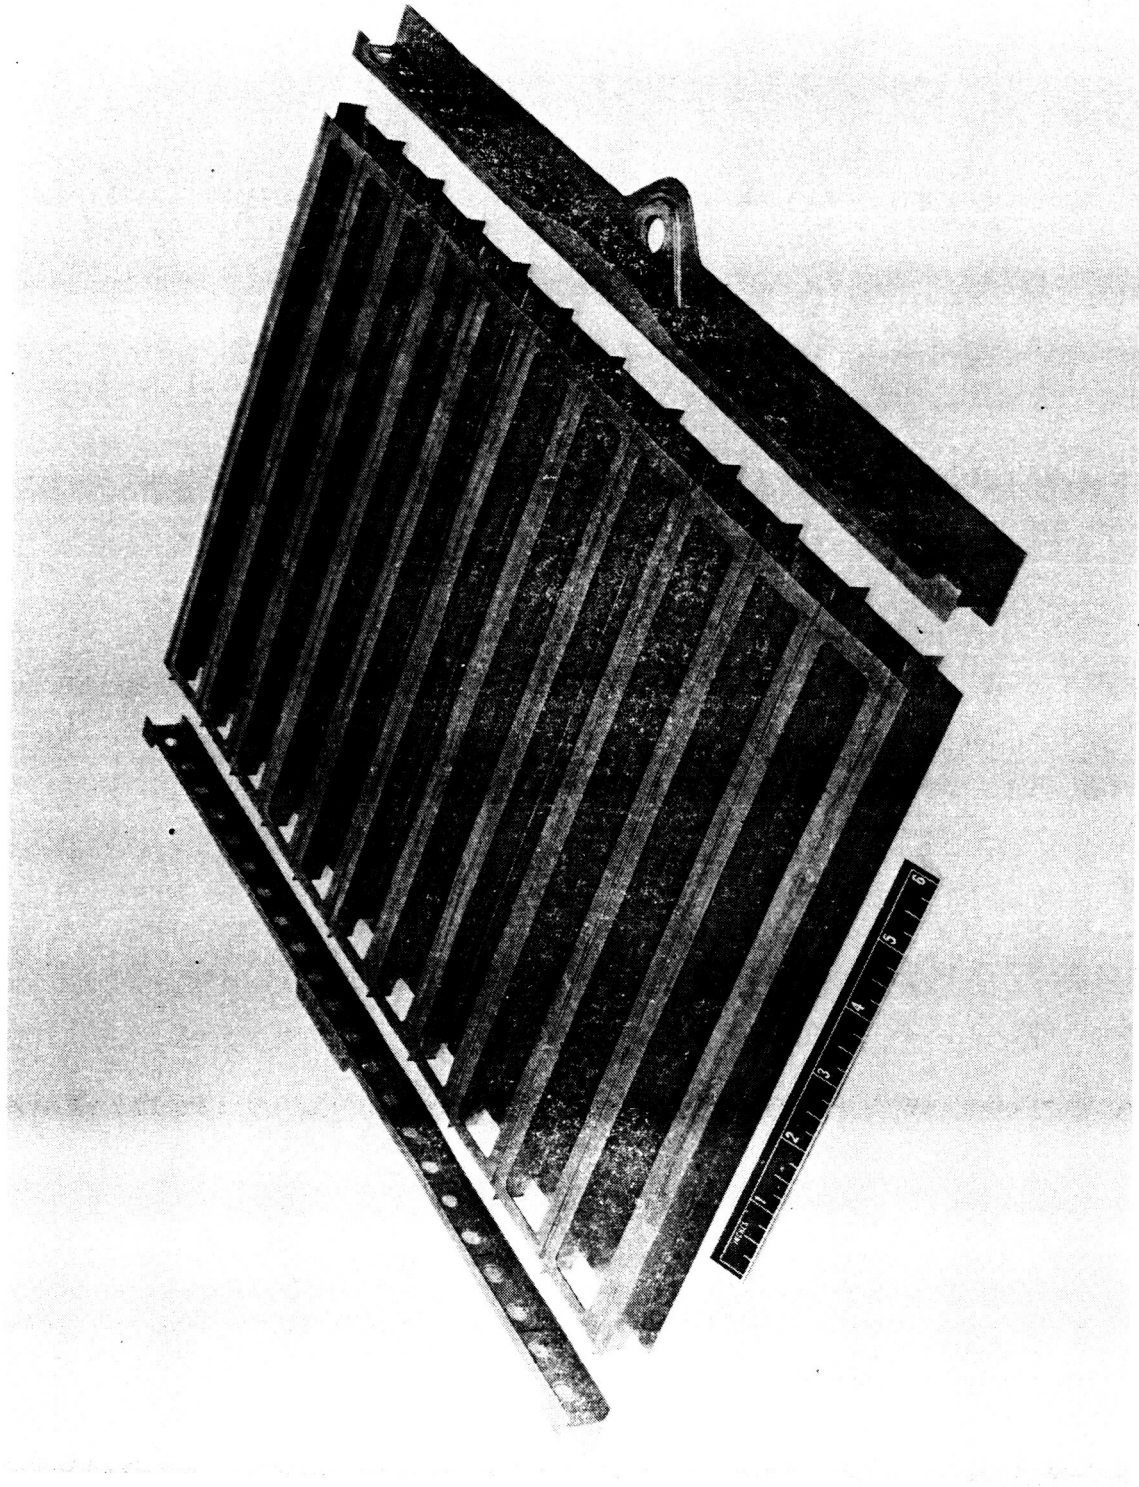
Figure 7-7. Tee-Stiffened Cb-752 Heat Shield Panel — Interior Side Prior to Final Weld (Photo No. 128070B)

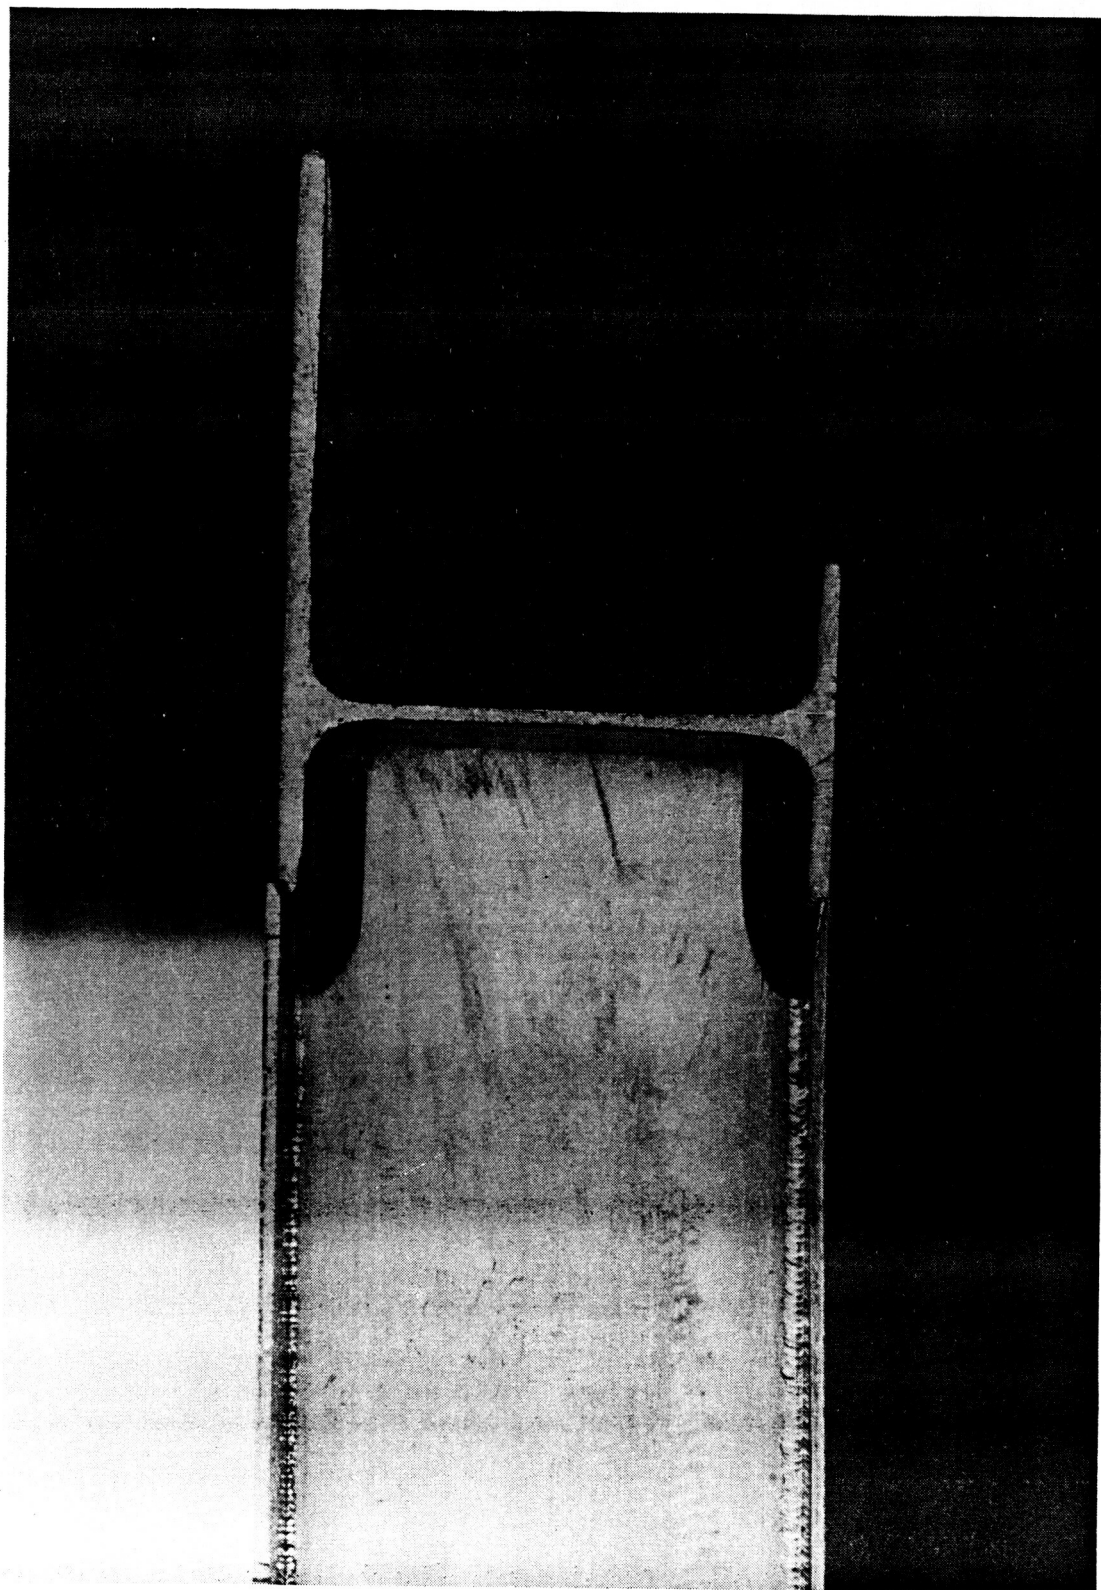
Figure 7-9. Detail of Closure Welds — Welded Panel to Beam — Ready for Welding.
Tee-Stiffened Cb-752 Heat Shield Panel (Photo No. 128068B)

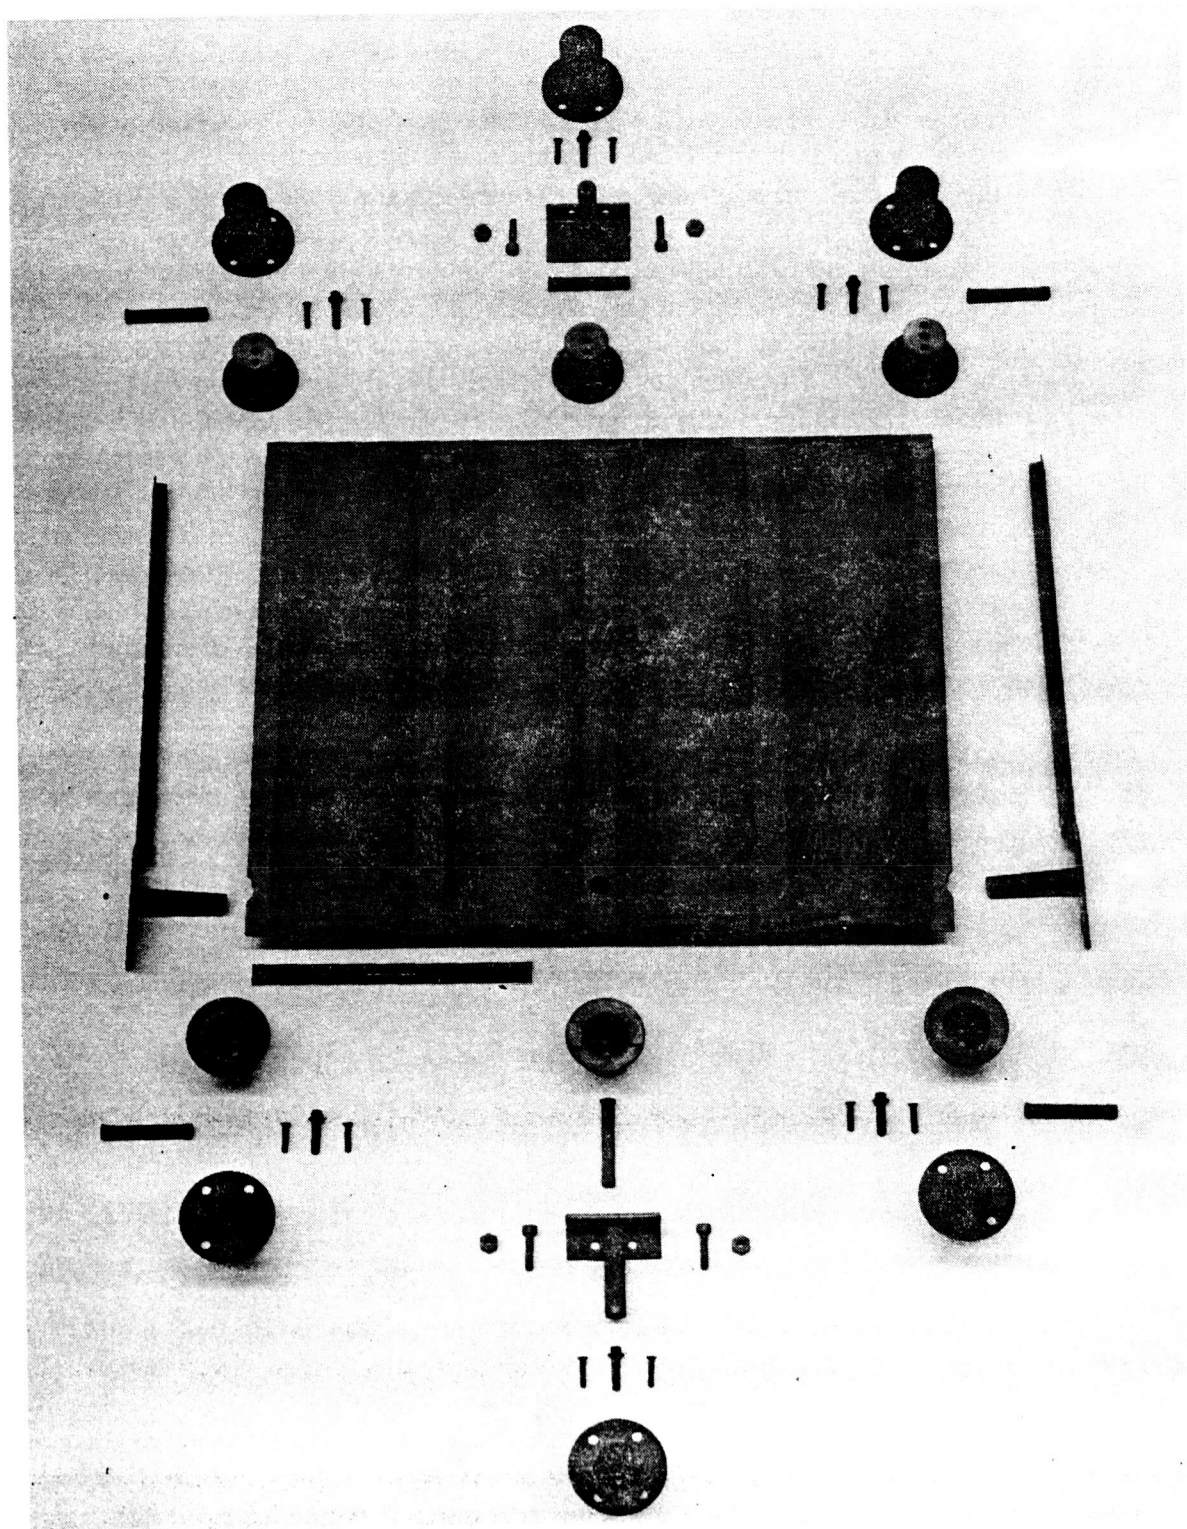
Figure 7-18. Open Corrugation TPS Components Prior to Testing (Photo No. 130748B)

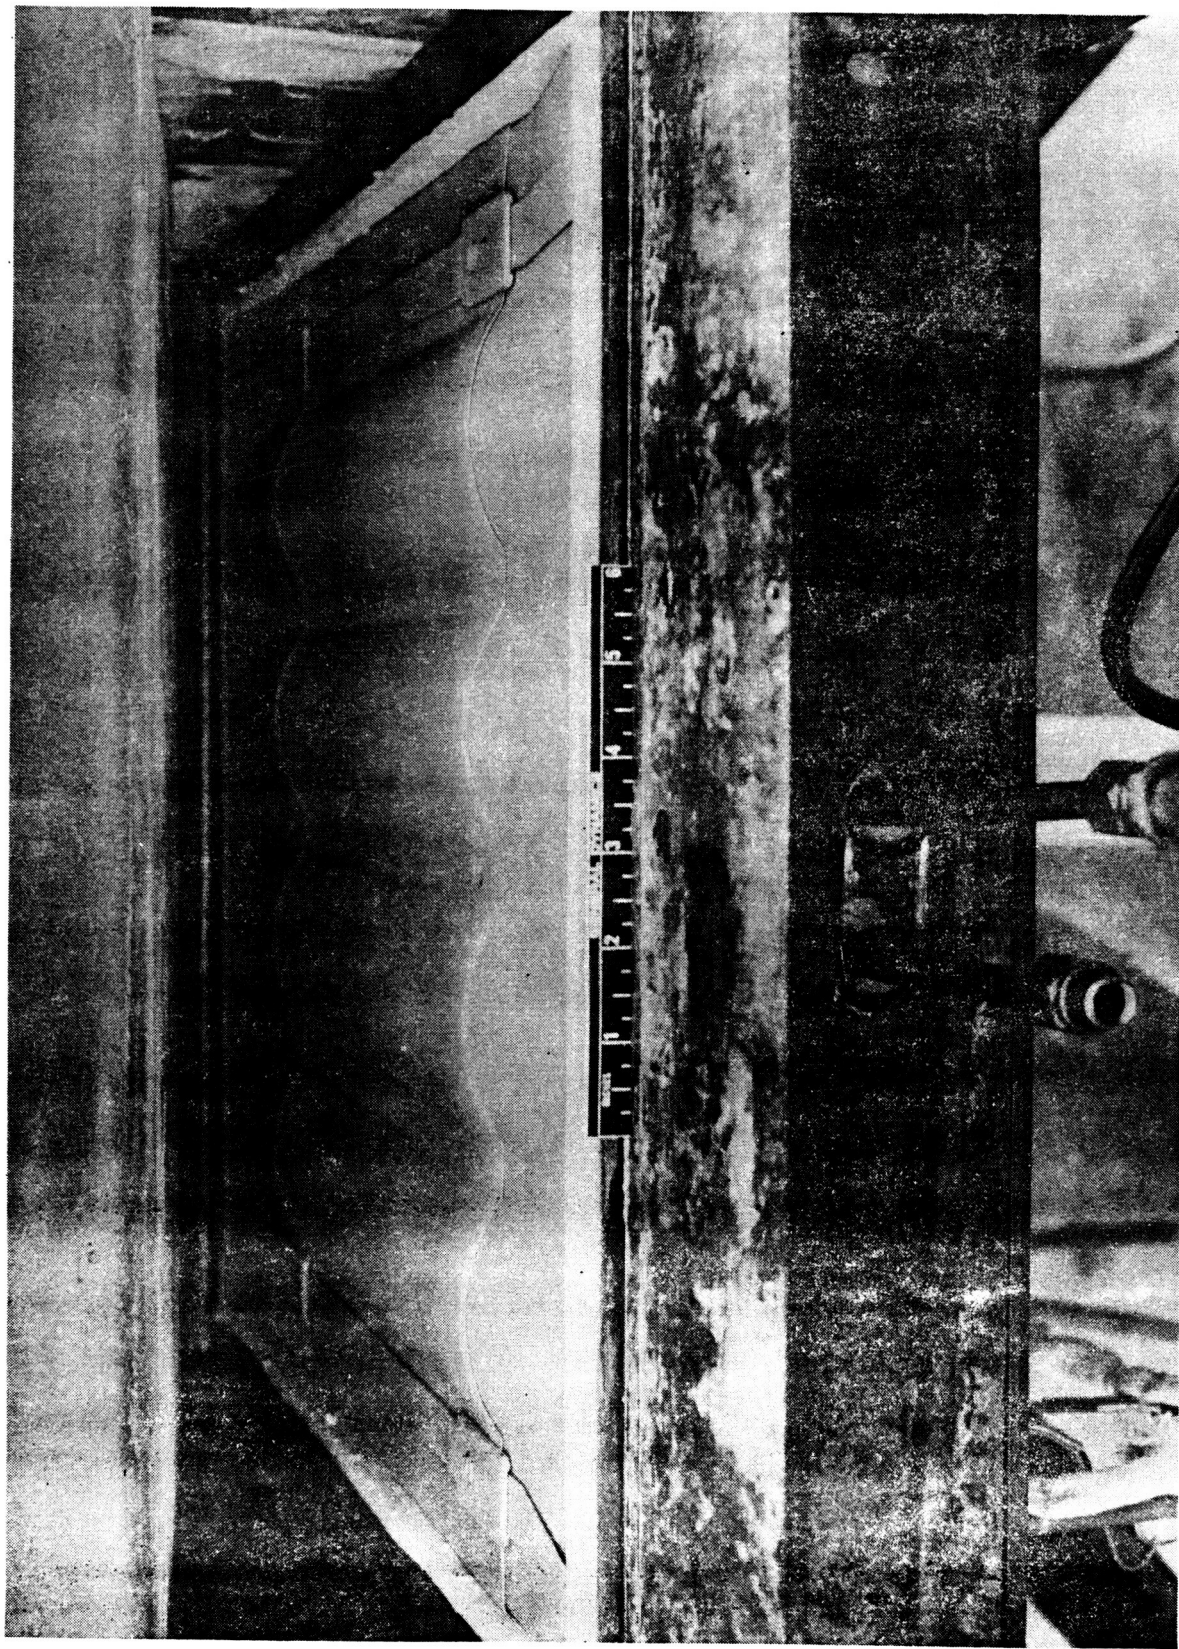
Figure 8-6. Open Corrugation TPS Specimen Installed in SEAR Facility Prior to Testing (Photo 132620B)

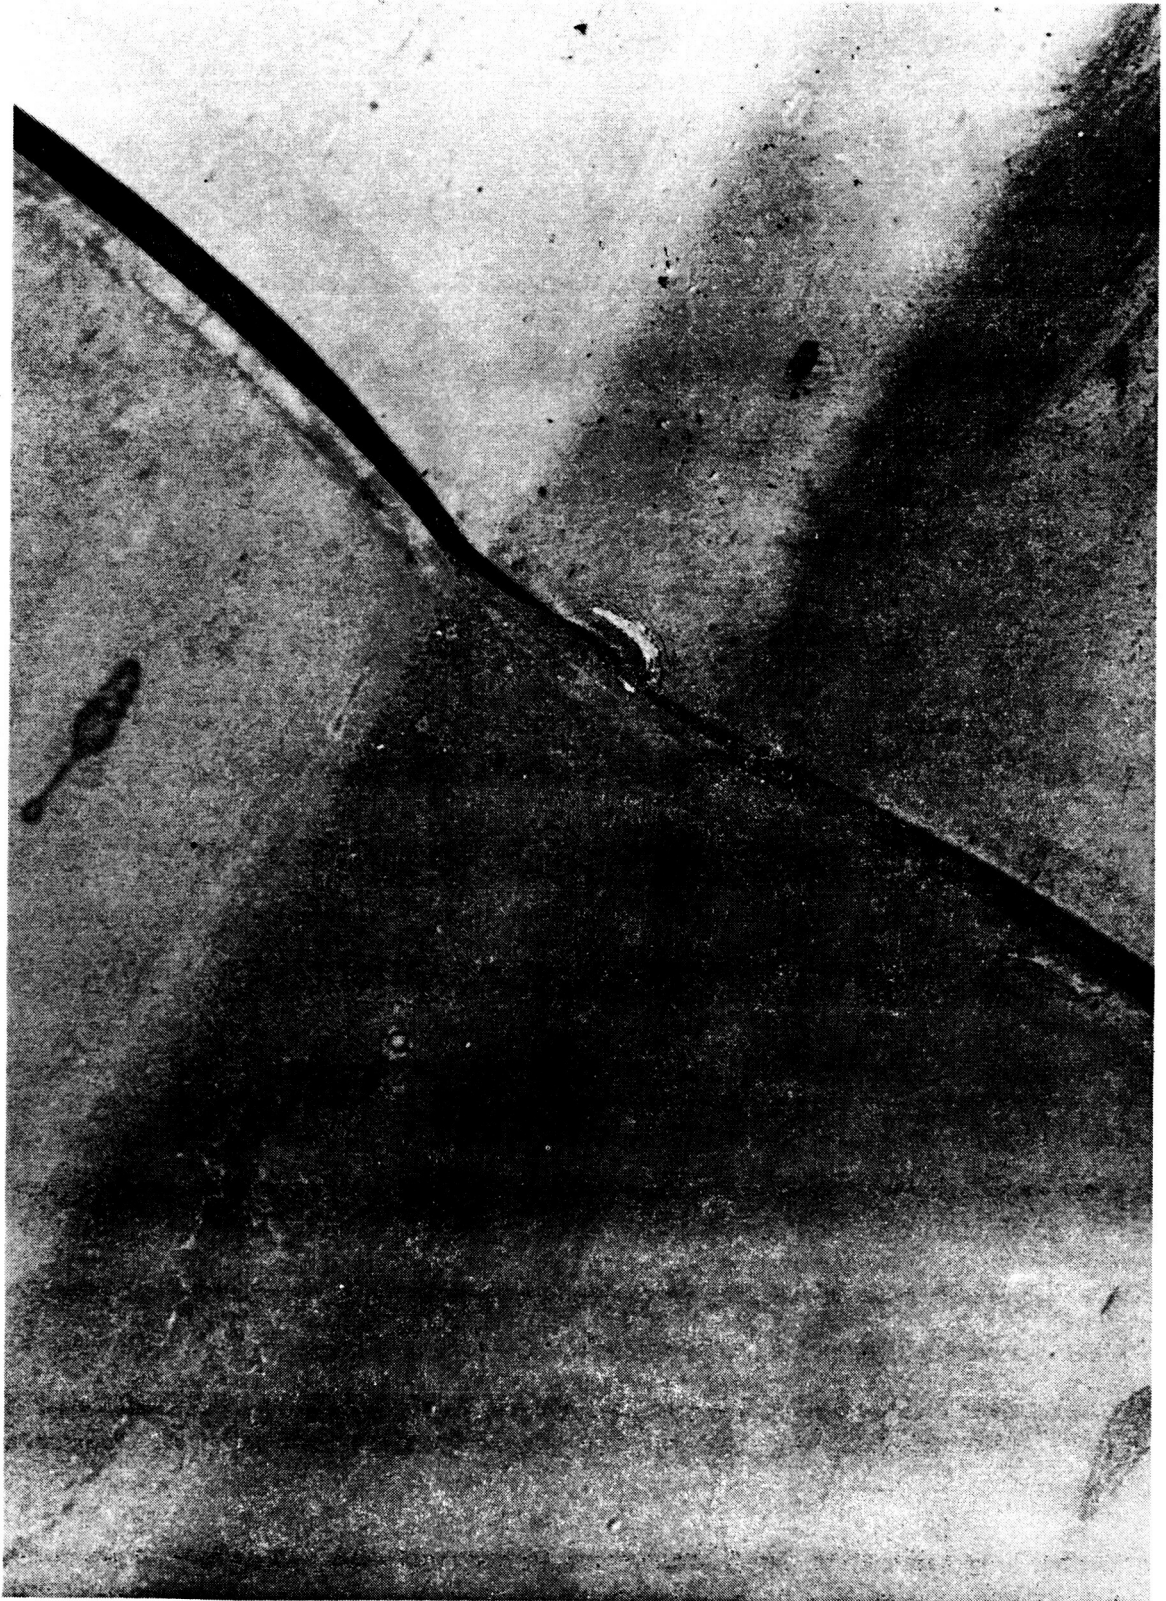
Figure 8-8. Panel Separation and Edge Damage of Open Corrugation TPS Specimen After 10 Hot Gas Flow Cycles (Photo 132919B)

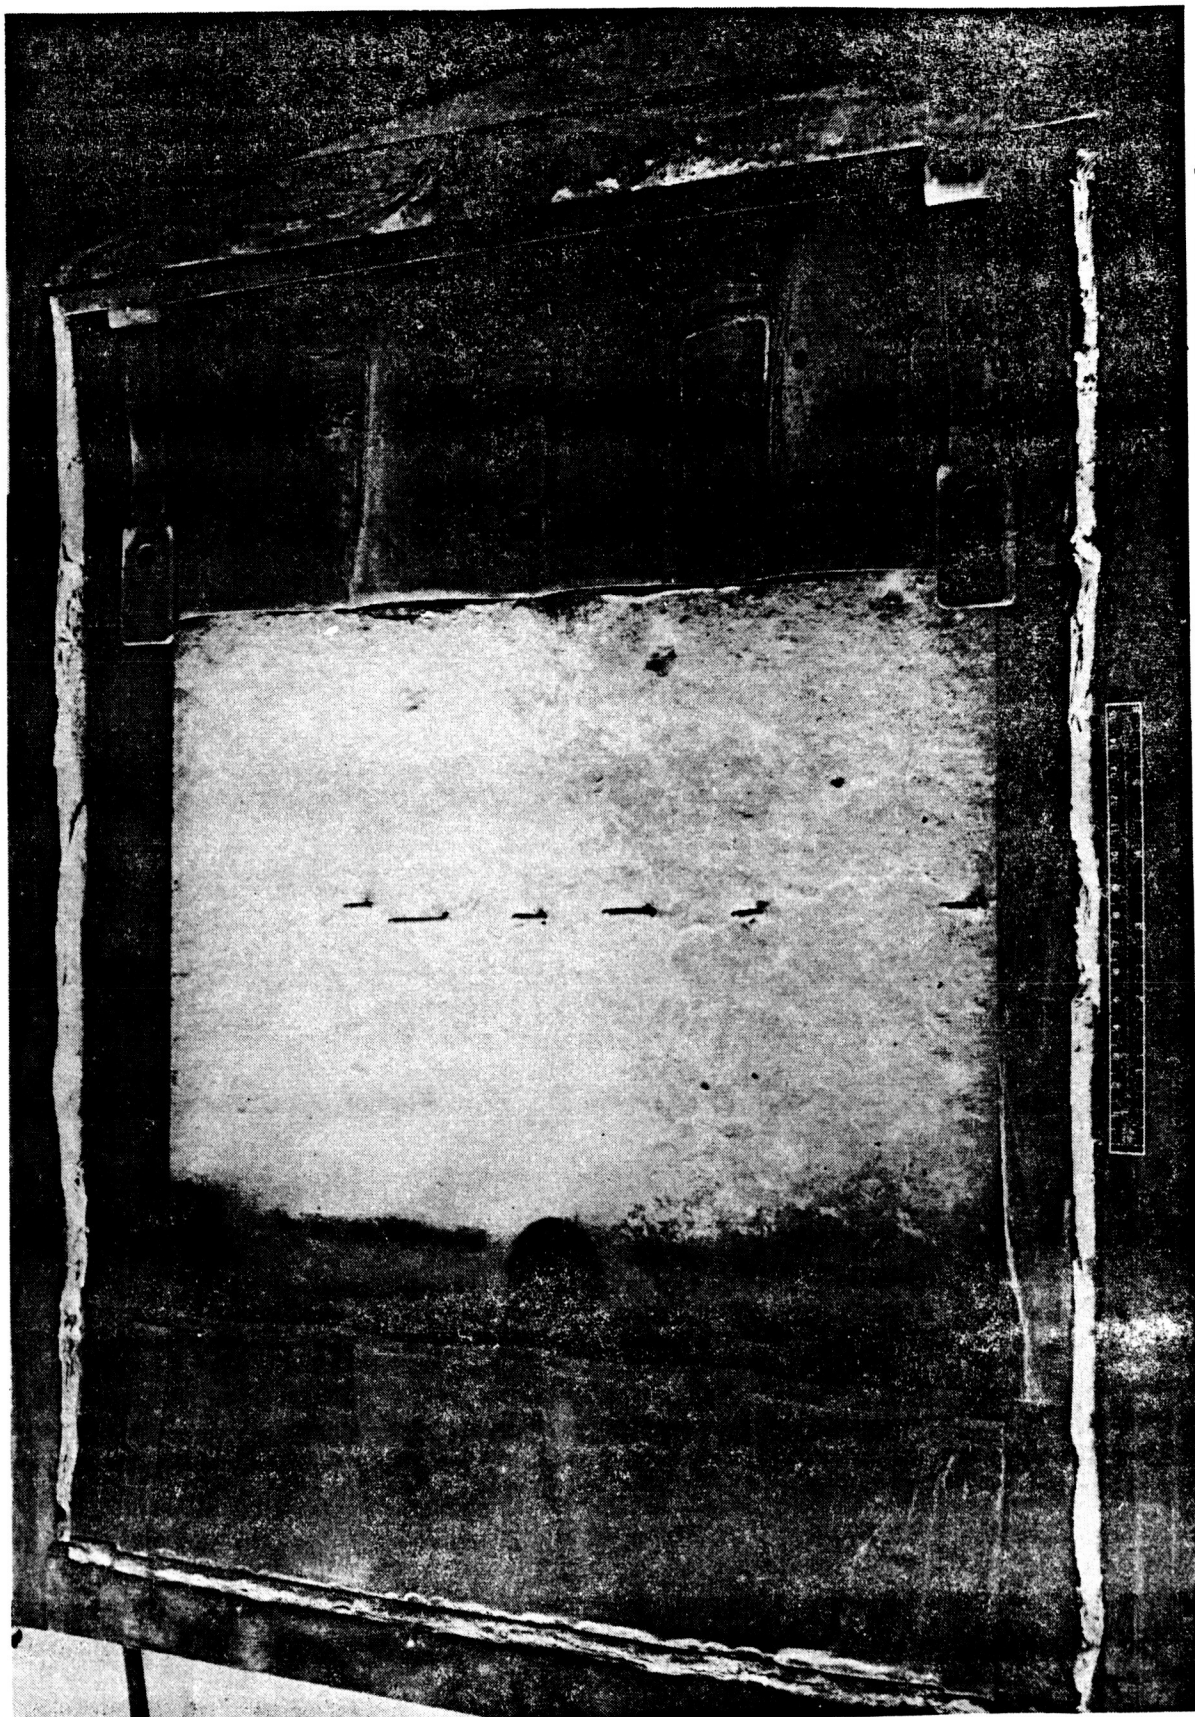
Figure 8-9. Open Corrugation TPS Specimen with Main Heat Shield Removed After 10 Hot Gas Flow Cycles (Photo 132916B)

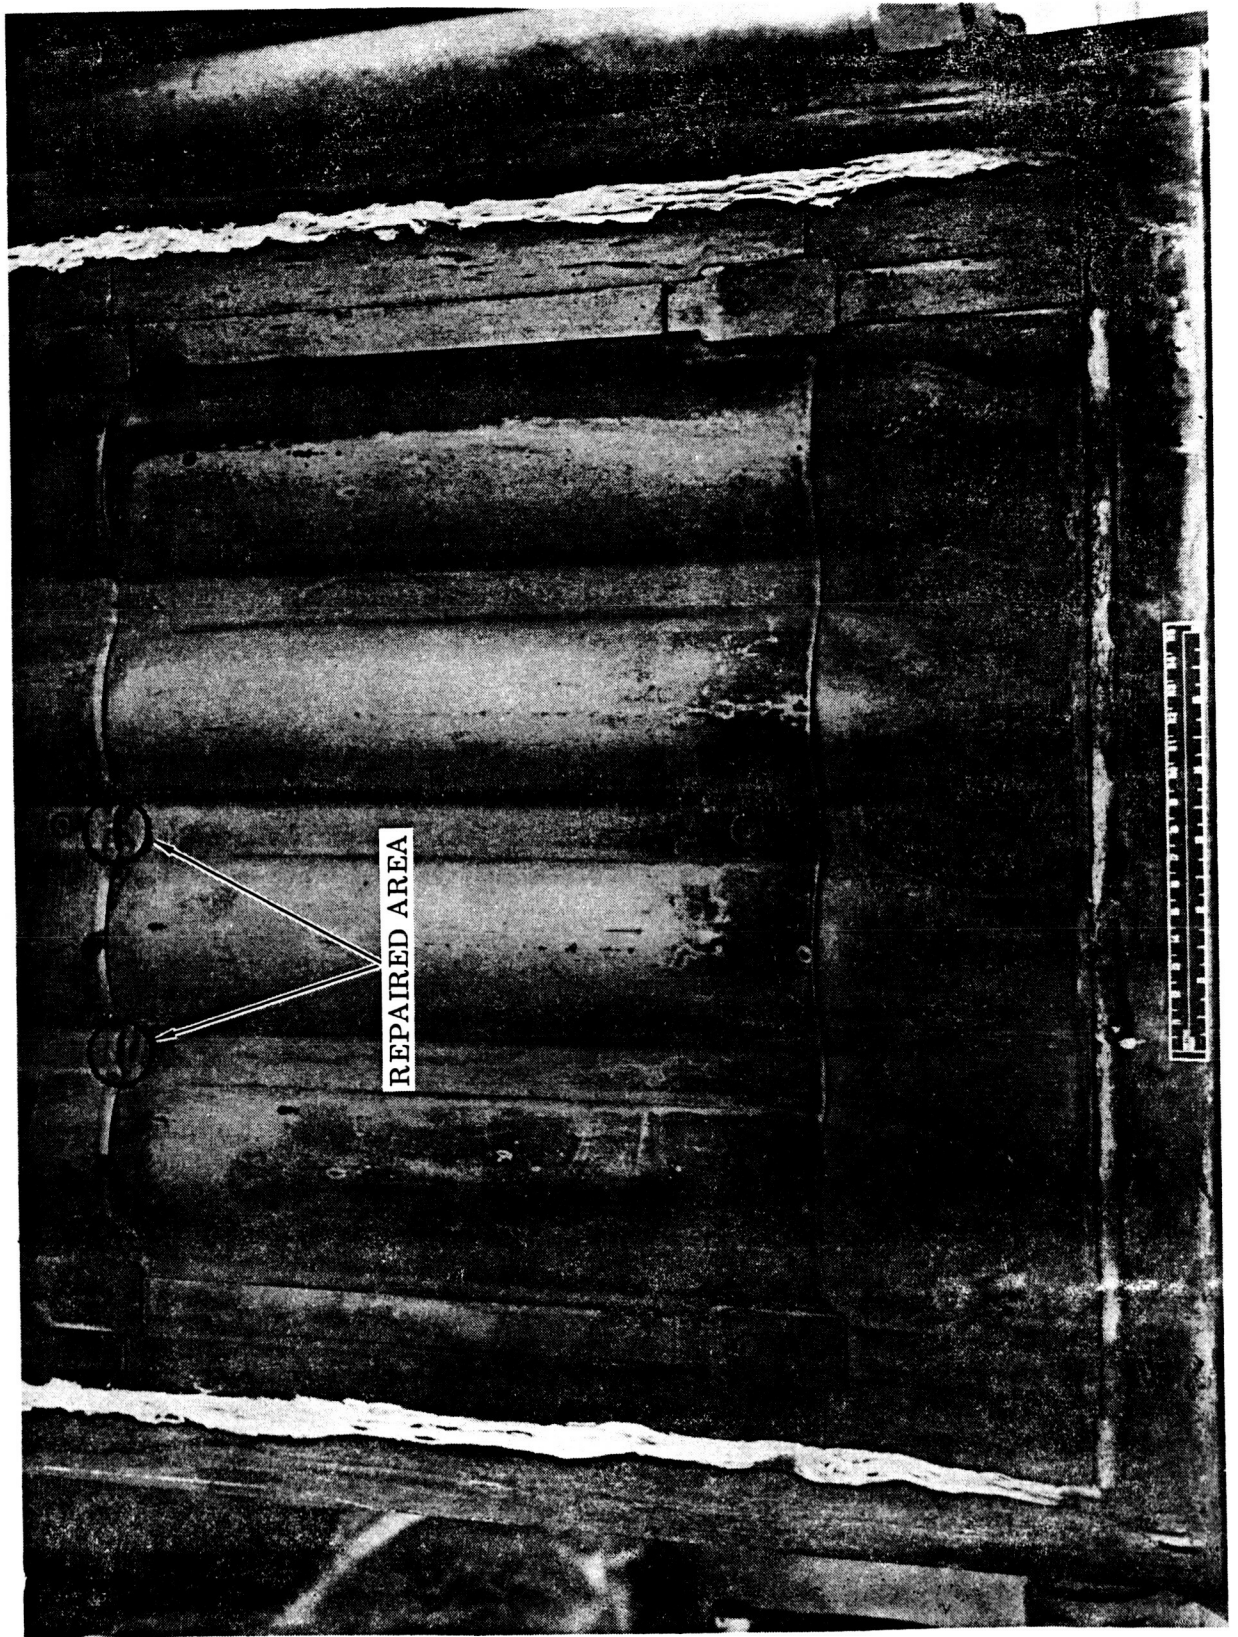
Figure 8-10. Open Corrugation TPS Specimen After 20 Hot Gas Flow Cycles (Photo 133245B)

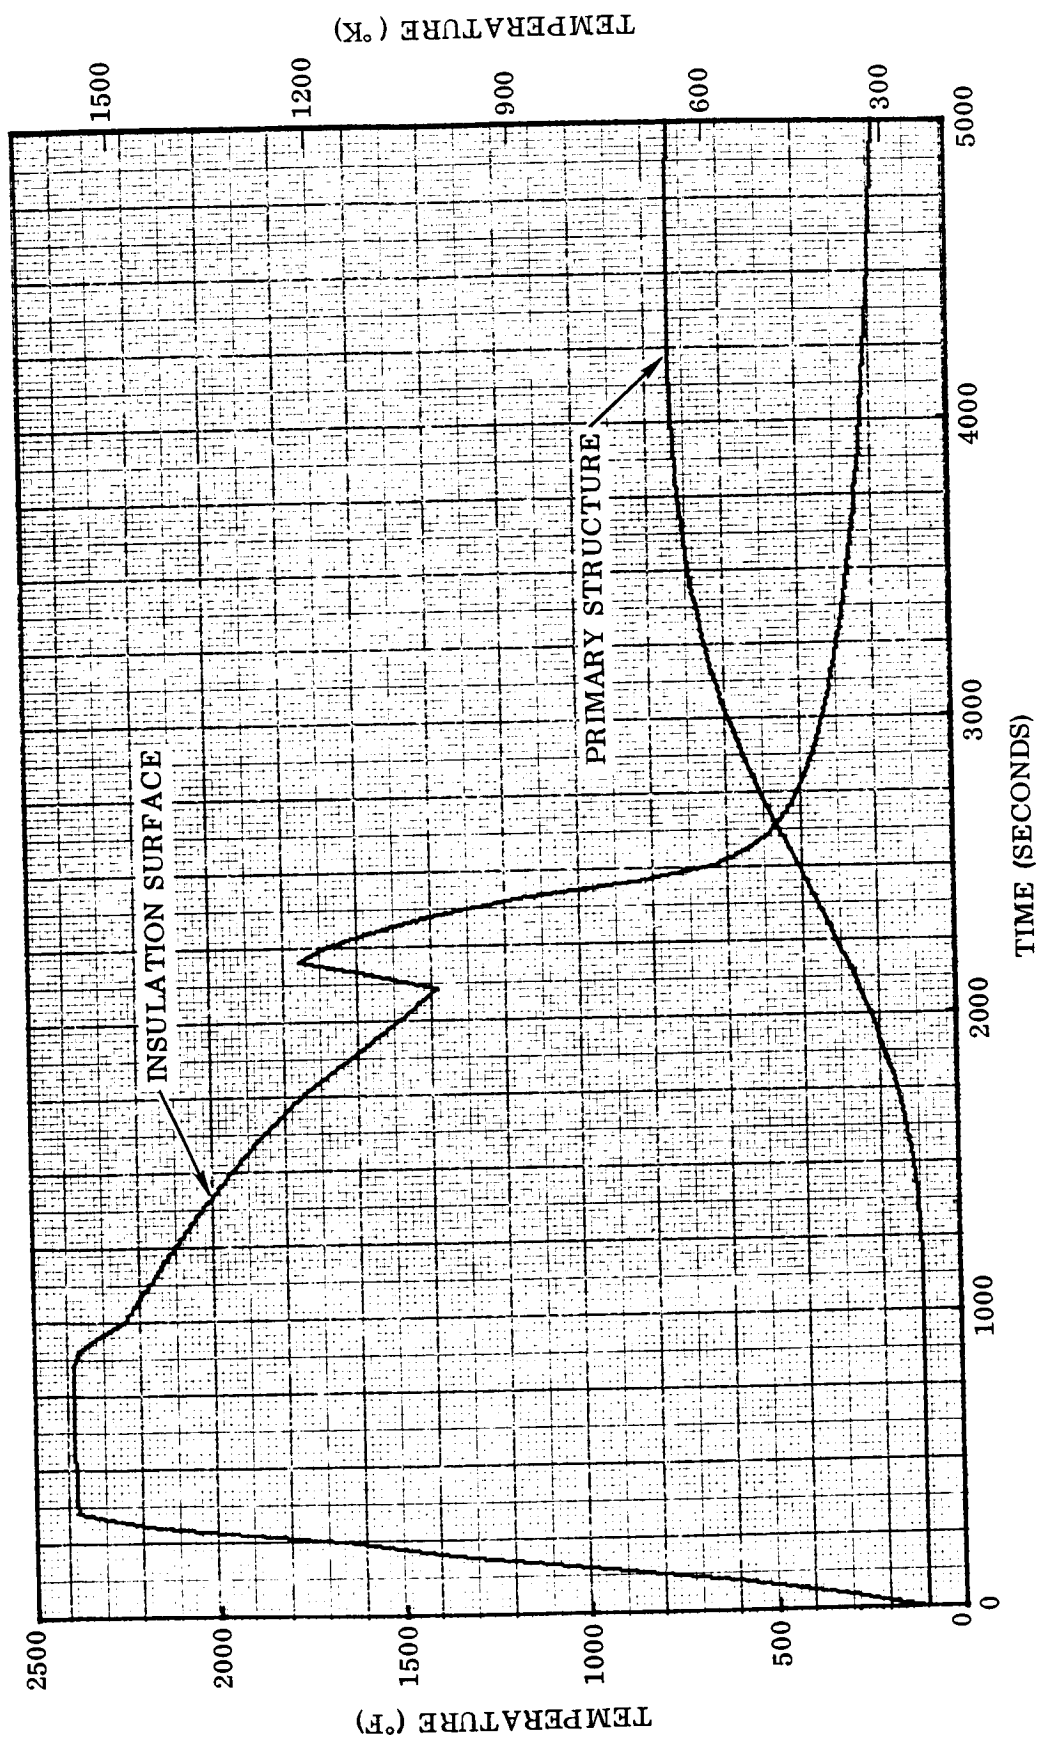
Figure 8-11. Predicted Structure and Insulation Surface Temperature History (Revised)

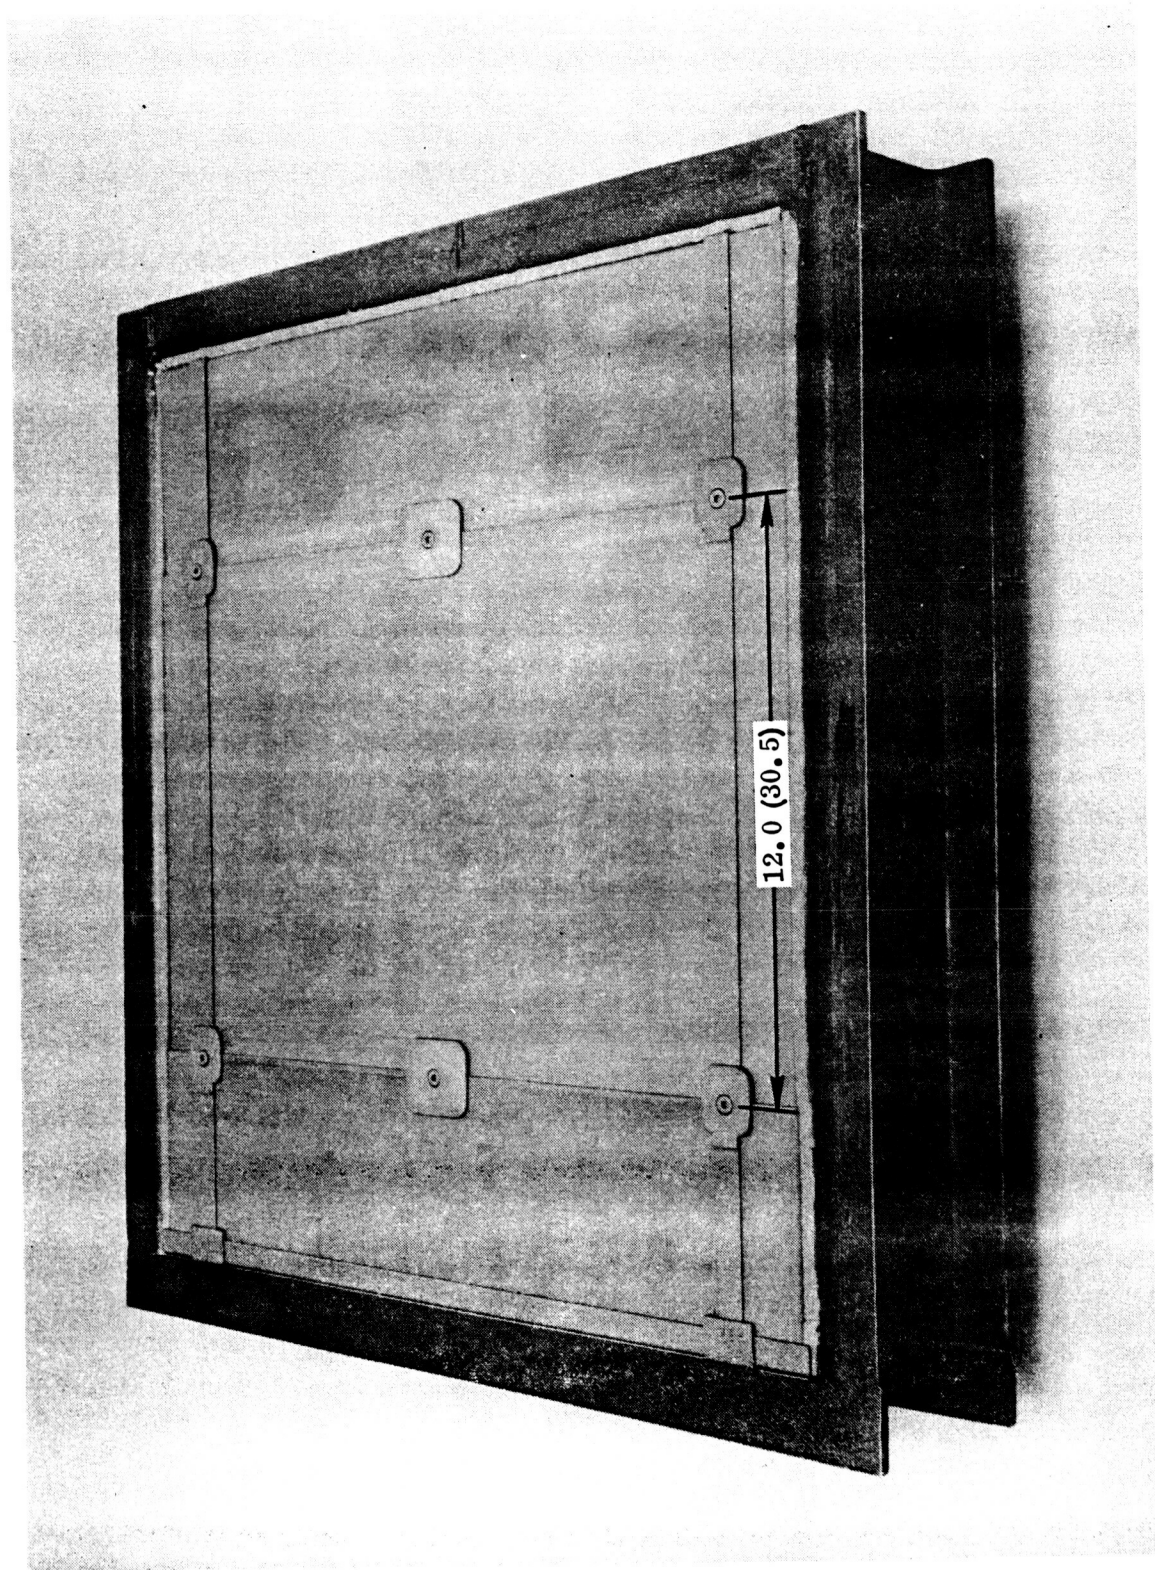
Figure 8-15. Unexposed Tee-Stiffened TPS Specimen -- Side View (Photo 120327B)

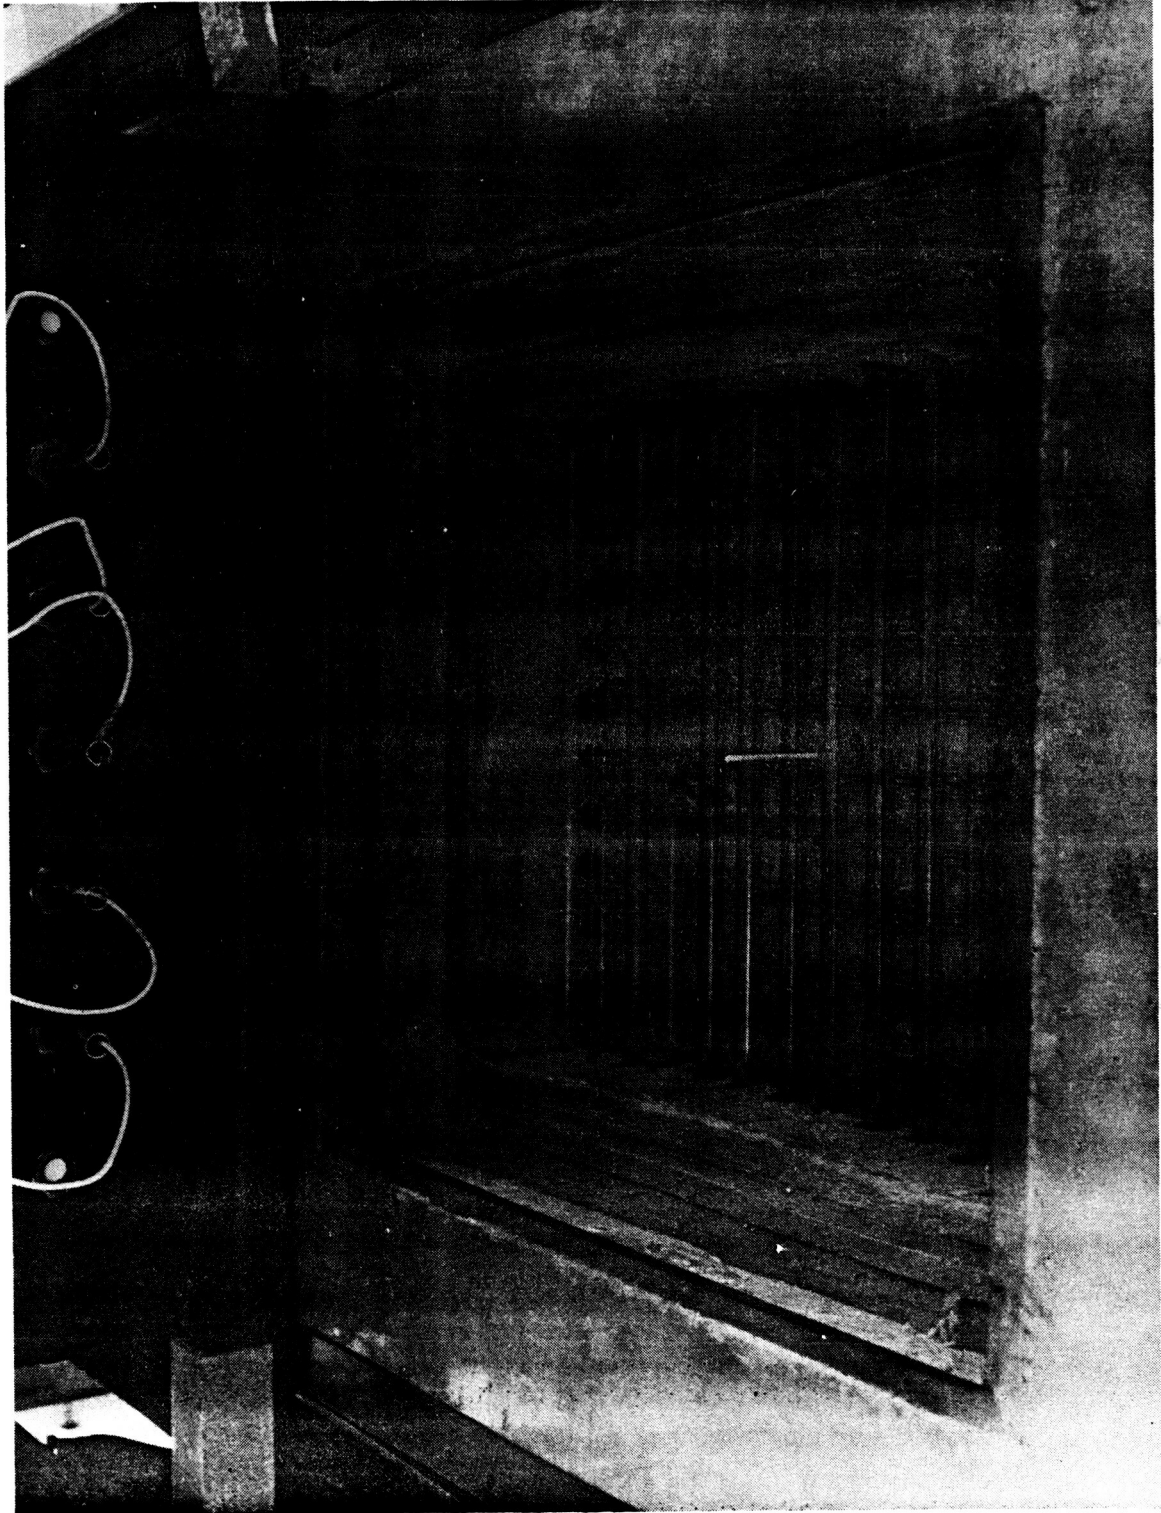
Figure 8-21. Cryotherm Heat Chamber (Photo 132764B)
